# **Study of Transportation Accident Severity**

**Marvin Resnikoff**

**Radioactive Waste Management Associates**

**Nevada Nuclear Waste Project Office**

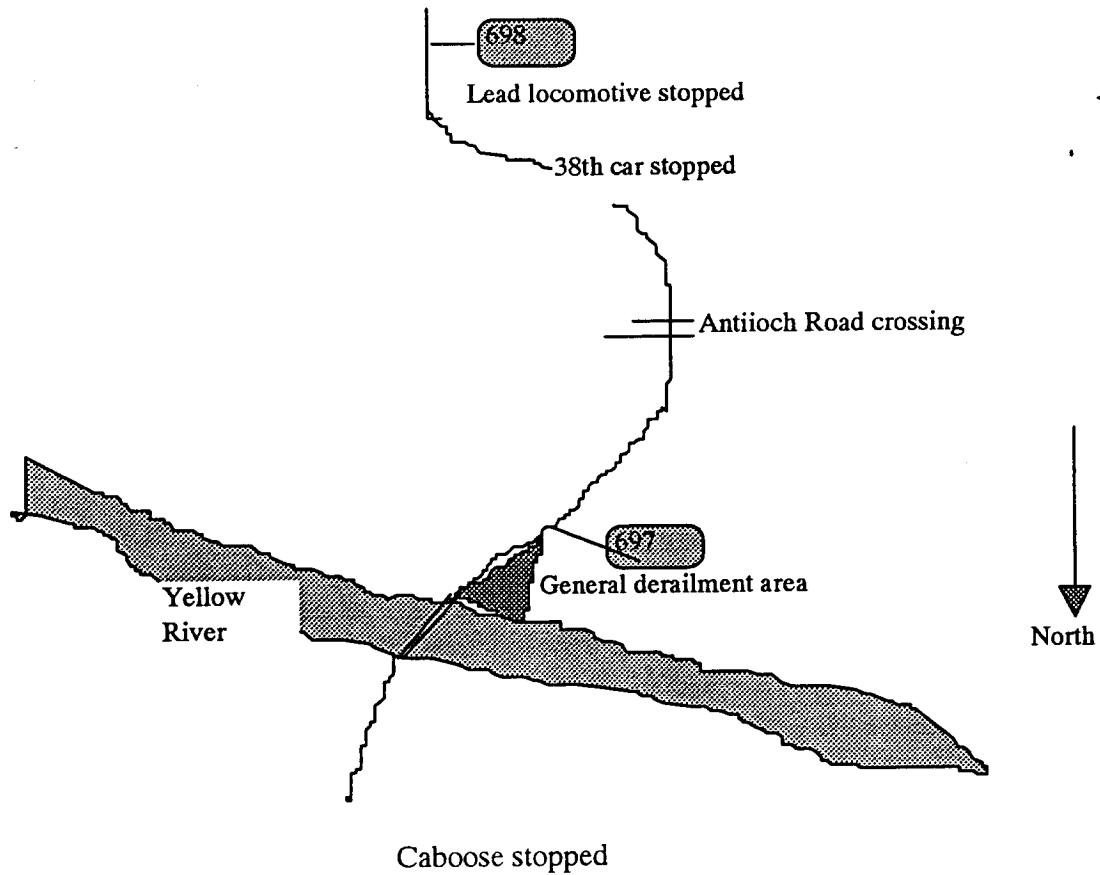
**Figure 1. Louisville & Nashville Railroad Company, Freight Train Derailment and Puncture of Hazardous Materials Tank Cars, Crestview, Florida, April 8, 1979**

Emergency response network faulty. Officials should know within minutes after notification the extent of dangers. Early outbreak of fire lofted materials. Sparsely-settled area. Allowed less casualties. During first day, communications with command post were extremely heavy. Lack of single emergency number for local personnel to call. Uncoordinated dispatching of experts to the scene. Federal and industry personnel sent to the scene were not dispatched by persons in command of emergency response operations. The use of the Air Force AC 130 aircraft with communication links to ground observers was essential.

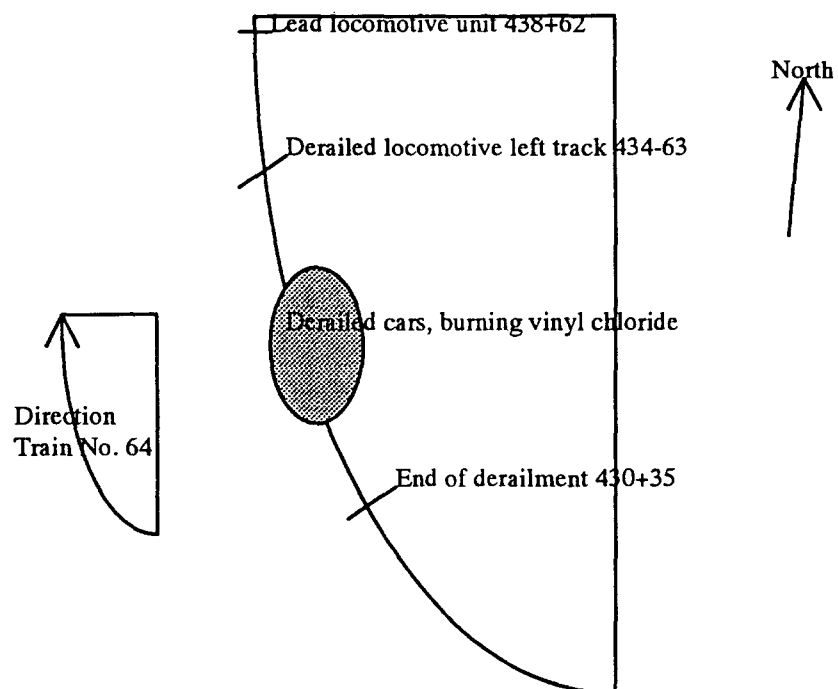
**Figure 2. Illinois Central Gulf Railroad Company Freight Train Derailment, Hazardous Material Release and Evacuation, Muldraugh, Kentucky, July 26, 1980**

All cars remained coupled during the initial run-in until the cars jackknifed. An inspection of the 7th care revealed a tear about 2 1/2 inches long and 1/2 inch wide at the center of the tank. A large burned area was noted in the 8th car where fire impinged for more than 72 hours. About 30% of the tank contents was vented through the safety valve. Computer simulation estimated the train operating at 36 mph, 6 mph over the speed limit.

The momentum of the four derailed locomotives caused it to move a distance of 428 feet, breaking rails, and tie plates and forcing the rails outward. The locomotives left the track structure and traveled an additional 219 feet before overturning. Many excessively worn tracks were noted in the area.

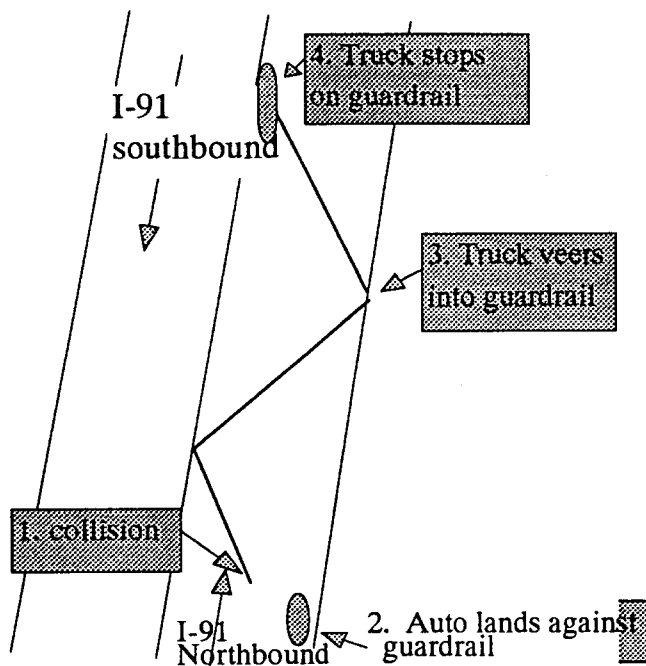
The fire completely destroyed the tractor trailer and caused significant damage to several containers and their contents. During the fire, eight containers fell off the trailer from a height of about 7 ft and sustained minor damage during the impact. The fire consumed the wood outer containers and caused damage to the inner metal containers. Localized regions near the tires reached temperatures of 1800 °F. Most of the containers endured flame temperatures of 1300 °F or less. The plastic fuel rod separators and foam protection for the fuel assemblies burned during the fire. Some of the clad tubes had swollen due to the increased in pressure within the fuel rod, estimated to be 1500 °F.

No release of radioactive material from the containers. Only minor injuries in the accident.

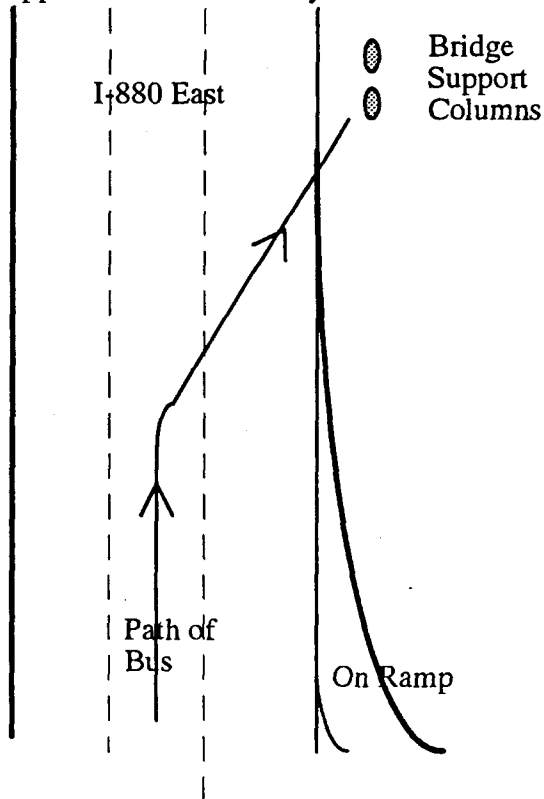
The basic structure of the bus was light gauge steel and aluminum. The engine and transmission were in the rear. The bus engine was governed so it could not exceed a speed of 67 mph. The overpass column penetrated the center front of the bus to a depth of 21 ft and rove the front axles and wheels back to the cargo dept. The driver's station and controls separated from the bus structure and were thrown against another support column, 52 ft beyond the point of impact. All seats failed. Apparently no brakes were applied. The driver may have had a heart attack because he was clutching his chest when

when the accident occurred. The driver was 45 lbs overweight. The passengers who were thrown out of the bus or impacted the column died. The calculated acceleration forces were 7.5g, with an approximate duration of 0.42 seconds, within human tolerance. Decelerated from 65 mph in 21 ft.

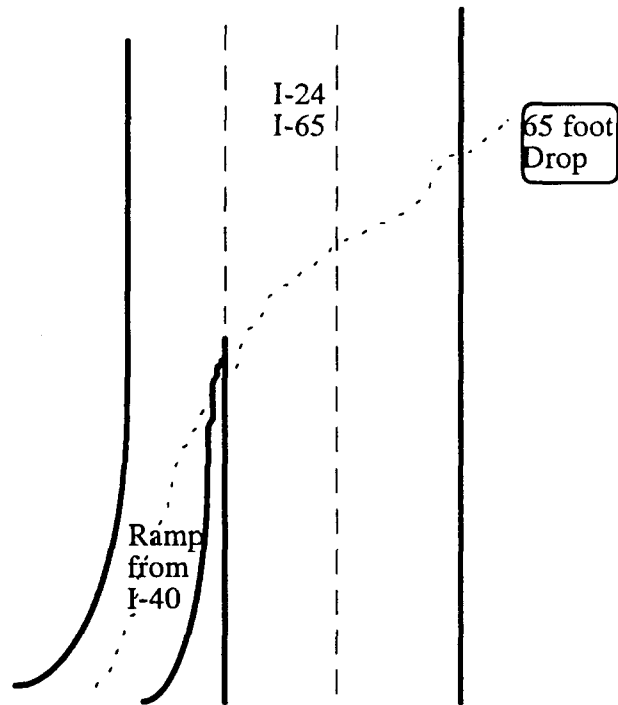
across two lanes, mounted the curb, overrode the box-beam and plunged through the bridge rail and fell 65 ft to the ground.

The bridge rail consisted of vertical posts 2'11" high and 3 horizontal rails. At the time of the accident, the replacement supports struck by the car were merely resting on the curb without actually being attached to the curb or the bridge structure. The curb, box-beam guardrail and bridge rail were the only components of the bridge damaged. 65 ft of guardrail deflected beyond the alignment of the bridge rail.

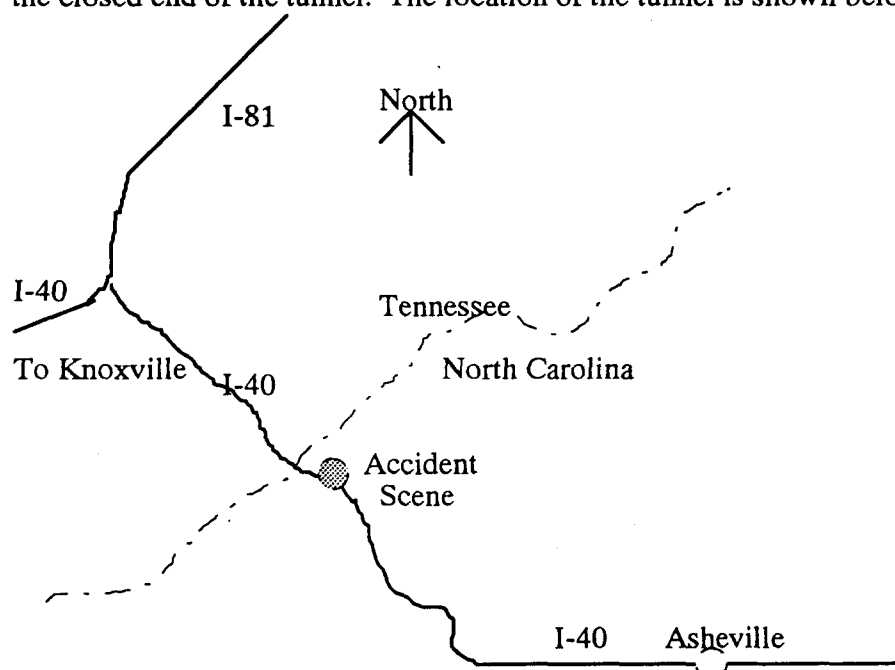
Figure. Rock slide on I-40 closing tunnels 4 mi from Tennessee border.

Others truckers in the tunnel were immediately forewarned of accident by CB radios and jammed brakes, avoiding further accidents. The slide was blamed on the spring thaw and supposedly was due to freeze/thaw cycles and perhaps explosions to make tunnel. Numerous accidents occurred along alternate routes. Traffic was detoured onto 2-lane mountain roads. One tractor trailer plunged several hundred feet down a mountain near Hot Springs when its wheel dropped off the highway shoulder.
